## **MARINE INVESTIGATION REPORT**

**M99W0033**

**NEAR-CAPSIZING**

**THE SMALL FISHING VESSEL "WESTISLE"  
OFF CAPE BEALE, BRITISH COLUMBIA  
1 MARCH 1999**

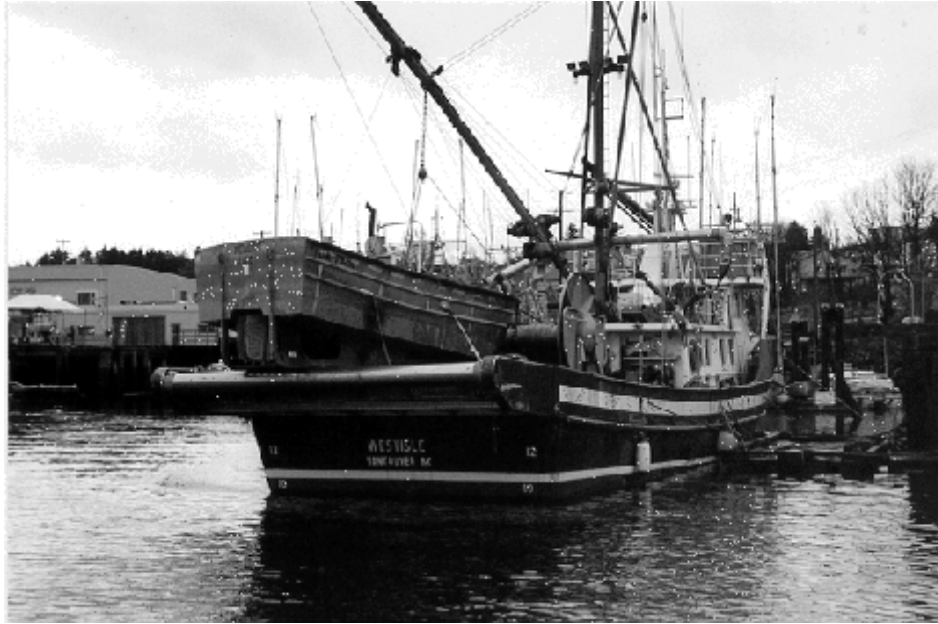
The "WESTISLE" on 3 March 1999, secured at the premises of Alberni Engineering in Port Alberni, B.C. Note the stern of the work boat is located to port of the centreline, where it was placed at the time of the occurrence.

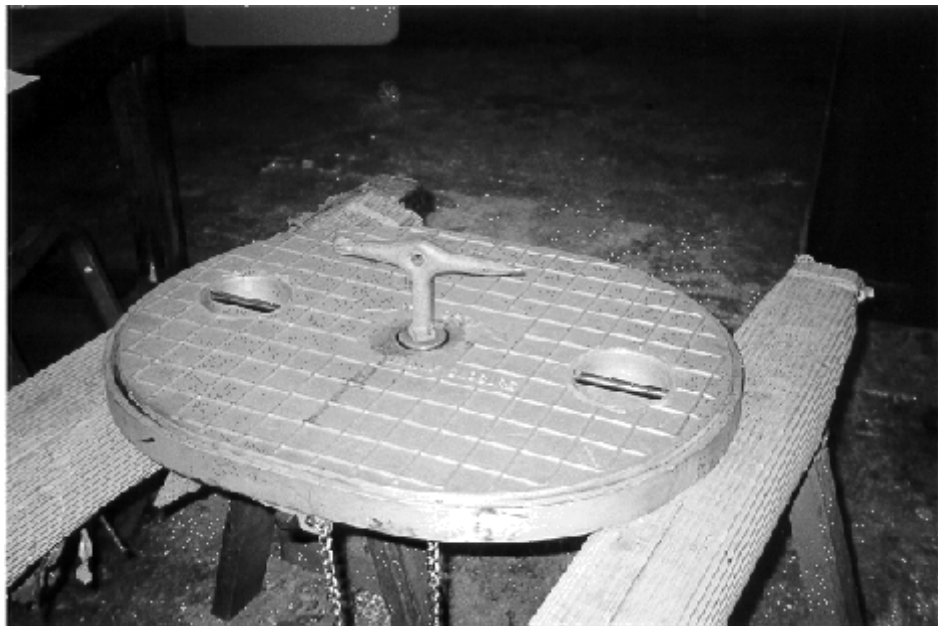
The cover for the starboard flush-fitting deck scuttle had no visual indicator to determine if the cover in the scuttle's aperture was secured or was merely in place and unsecured. The lack of any positive indication could lead the crew to believe that the deck scuttle cover was well secured and watertight when, in reality, it was neither. The investigation revealed that the cover's locking mechanism had a tendency to jam against the scuttle's under-deck framework. This would cause the unsecured cover to be prone to dislodge in rough seas, thereby compromising the watertight integrity of the vessel's hull. There is no regulatory requirement for the deck scuttle fittings to be type-approved nor were they type-approved. Single-action closing mechanisms with positive indication that the scuttle covers are in the secured position are readily available on the marine market.

Although required by regulation, the deck scuttle cover was neither hinged nor secured by a chain to the vessel's structure. Consequently, when the cover became dislodged, it was lost. Thus, the designed means to restore the compartment's watertight integrity was no longer available.

1. The design of the deck scuttle cover did not permit a person on deck to visually verify that the cover was properly secured.
2. The deck cover's securing arm had a tendency to jam against the scuttle's under-deck framework without effectively securing the cover.

4. The deck scuttle covers were neither hinged nor secured by a chain to the vessel's structure.
5. The vessel developed a starboard list when seawater down flooded through the improperly secured and subsequently dislodged flush-fitting deck scuttle cover.

New aluminum flush-deck cover designed by Manly Marine Closures, Ltd., identical to that which became dislodged during the occurrence. Note the recessed locking bolt, with its fitted bronze key in place.

Following the occurrence, the flush-fitting deck scuttle securing mechanism was modified.

Transport Canada instructed its western region marine inspectors to verify that all fishing vessel fish scuttle covers are permanently secured to the vessel.

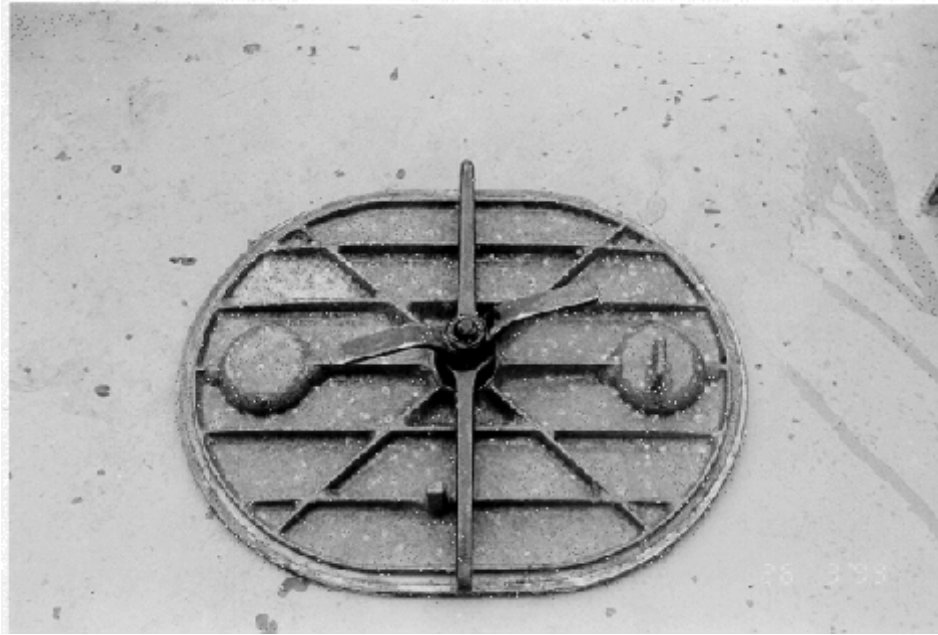
the scuttle cover locking mechanism to jam against the under-deck framework, and the practice of not securing the deck cargo.

Under-deck locking mechanism of an aluminum flush-deck cover, designed by Manly Marine Closures, Ltd., identical to that which became dislodged aboard the "WESTISLE" on 1 March 1999

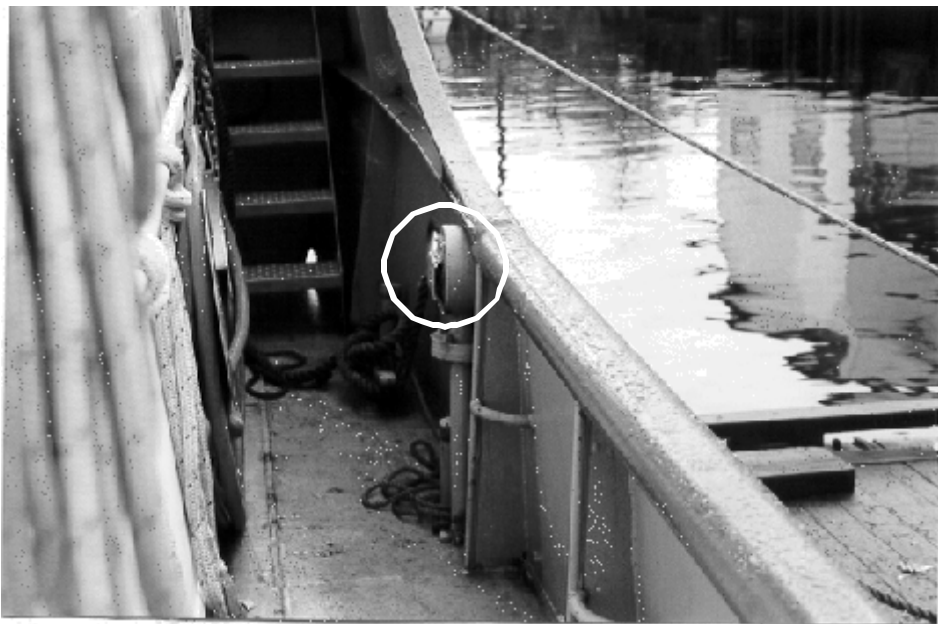
When the vessel suddenly heeled some 70° to starboard, the ball check valve in the fuel tank's fresh air vent became immersed and seawater entered the tank, contaminated the fuel, and subsequently rendered the main engine inoperable. The float-type air vent is designed to close the aperture under normal rolling conditions at sea and is ineffective when the vessel is heeled to large angles. However, the main engine functioned long enough to supply power necessary

8. Pumping ballast into the port forward cargo tank and repositioning the workboat contributed to the vessel's recovery.
9. With the vessel heeled some 70° to starboard, the ball check valve in the fuel tank's fresh air vent became immersed, and seawater entered the tank and contaminated the fuel, rendering the main engine inoperable.

Starboard fuel tank vent (circled) that became submerged during the occurrence and failed to prevent seawater from down flooding into the tank itself.

Transport Canada tested the vessel's starboard fuel tank vent valve and found it in good working order up to but not beyond 20° of incline.
